## Aviation Safety

# Maintainer

Issue 1/2003

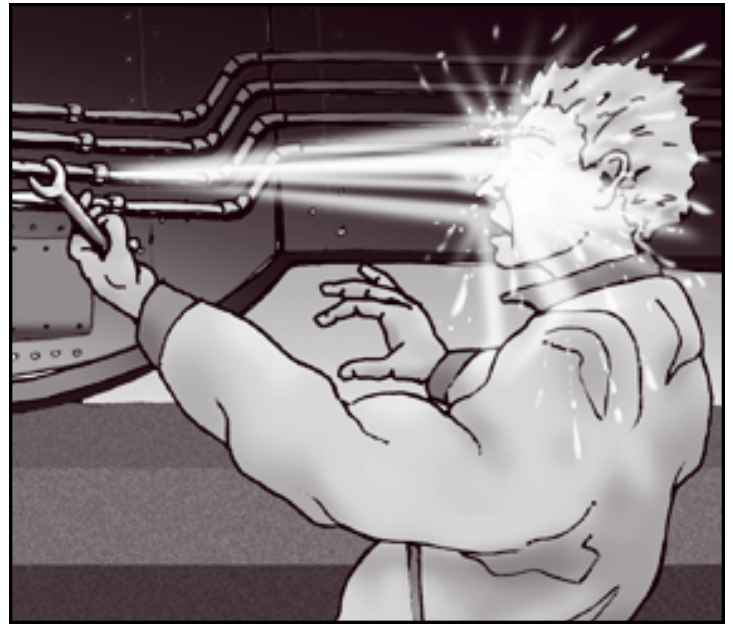
The new part had been fabricated for another make of aircraft and unbeknownst to everyone, the pressure resistance was half of that required. Nevertheless, an engineer was given the task of fitting the new part. When the line seemed secure, hydraulic pressure was restored and the line held the pressure. A flight was undertaken, but shortly after takeoff a low hydraulic quantity light came on and the flight had to return and land. As an aircraft maintenance engineer (AME) was inspecting the line, it suddenly burst and sprayed Skydrol all over his face, blinding him and drenching his work clothes and skin.

There were no emergency eyewash or chemical burn stations anywhere nearby nor were there any portable eyewash bottles available. A colleague had the quickness of mind to take the blinded and suffering AME to the aircraft lavatory and assist him in washing his face and eyes with water from the sink. This probably saved his eyes. He suffered

first-degree burns to his face, neck, hands, arms and a number of other places on his body.

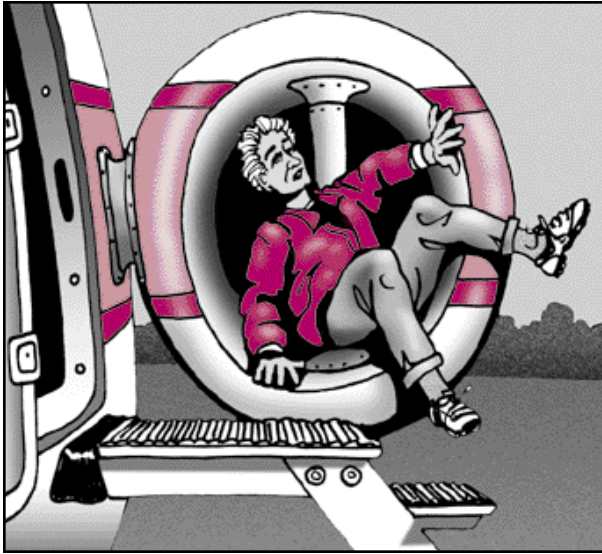
**Ramp worker narrowly escapes being ingested by the engine of a Boeing 727** —The captain of a Boeing 727 had arrived at the gate and left the No. 1 engine running at idle power because he could not get the aircraft to accept external power. Suddenly, the senior flight attendant came running up the aisle calling for the engine to be shutdown as somebody had been sucked inside. The captain immediately complied and then rushed out to investigate. Fortunately, by this time, the catering truck supervisor had been removed from the engine intake; he said that he didn't know that the engine was running. The catering supervisor had approached the rear aircraft door from the elevated walkway of the truck and had been immediately sucked into the turning engine. The engine suffered foreign object damage (FOD) and the man suffered a number of broken ribs, but amazingly he avoided major injury thanks to the quick intervention of the crew and the fact that the engine was equipped with fixed external guide vanes.
